Birkom Shock Comparison Durability Test

SGS Report No. 16Y-0075-352_REV.2

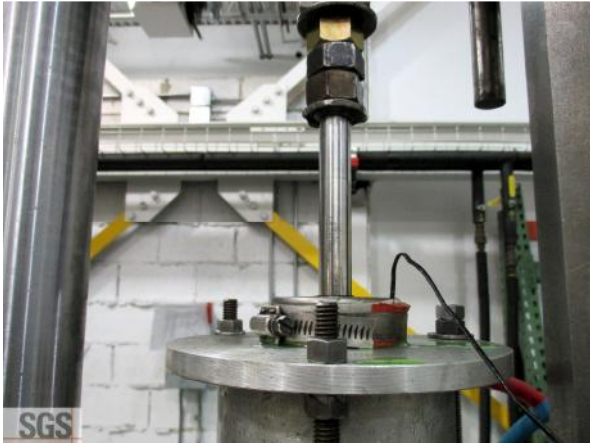
Photograph #3: Comparison Shock
Rod discoloration at 82,655 cyc.

| Sample | Rig | Start Date | End Date | Total Cycles | SOT Weight (g) | 1M Weight (g) | EOT Weight (g) | Comments |
|---|---|---|---|---|---|---|---|--|
| S.1916 | 1,2 | 6/17/16 | 9/5/16 | 1,310,825 | 3,354 | 3,159 | 3,147 | Suspend test. Sample 36% loss of load & Rod discoloration noted. No oil leakage noted. Replace with Slave Shock #3 (Replacement) |

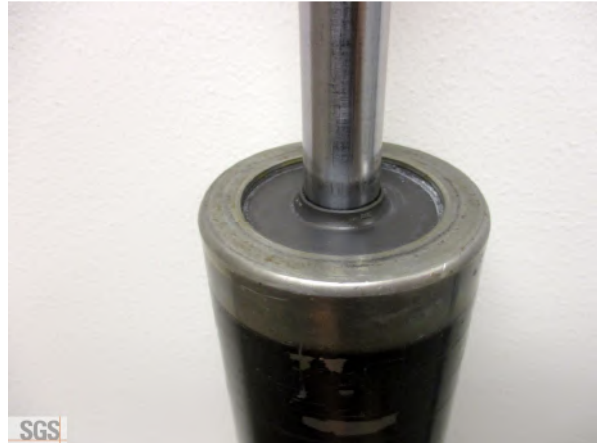
Photograph #4: Comparison Shock Post Test

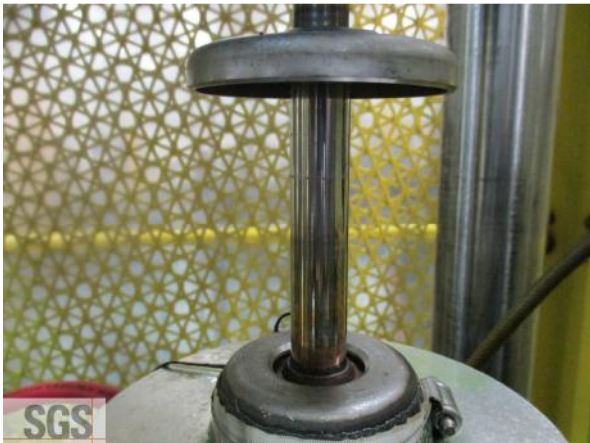
Photograph #5: Birkom#1, rod discoloration at 50,610 cyc.

| Sample | Rig | Start Date | End Date | Total Cycles | SOT Weight (g) | 1M Weight (g) | EOT Weight (g) | Comments |
|---|---|---|---|---|---|---|---|--|
| Birkom# 1 | 1 | 6/17/16 | 6/19/16 | 82,655 | 3,654 | NA | 3,645 | Suspend test. Sample 70% loss of load & Rod discoloration noted. No oil leakage noted. Replace with Birkom #2. |

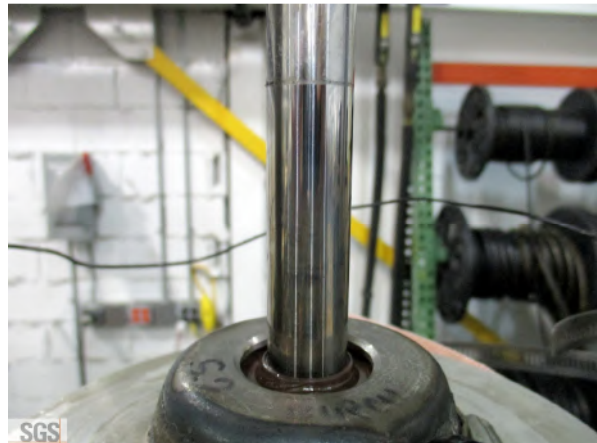
Photograph #6: Birkom#2, rod discoloration at 34,692 cyc.

| Sample | Rig | Start Date | End Date | Total Cycles | SOT Weight (g) | 1M Weight (g) | EOT Weight (g) | Comments |
|---|---|---|---|---|---|---|---|--|
| Birkom# 2 | 1,2 | 8/12/16 | 9/13/16 | 1,568,926 | 3,656 | 3,584 | 3,571 | Test Suspended per customer request. <i>Shock still operating normally.</i> Discoloration noted. No oil leakage noted. |

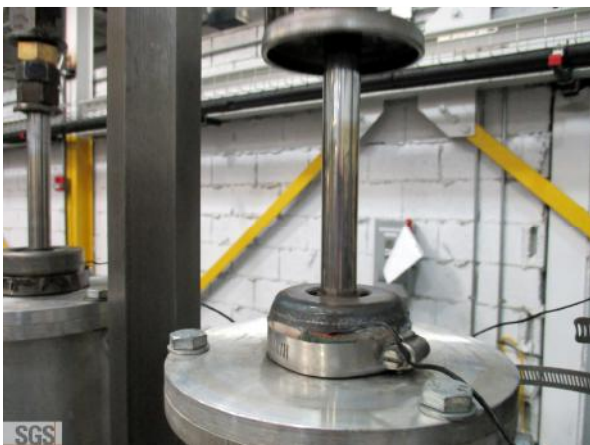
Photograph #7: Birkom#2, rod discoloration at 219,866 cyc.

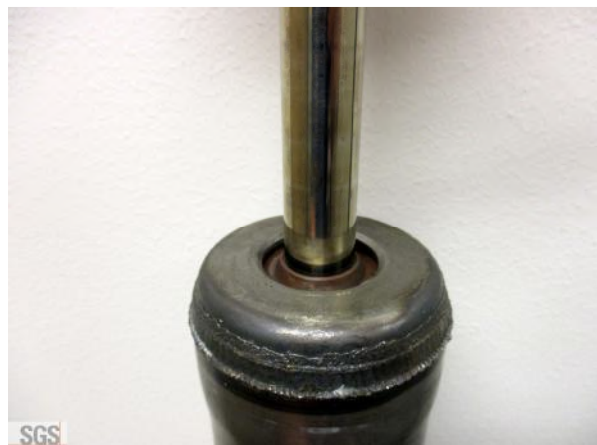
Photograph #8: Birkom#2 Post-test
